Omfattande reparation Tryckkärl P1 Hässelbyverket

Anna Gabrielsson 2025-04-03

Extensive repair and upgrade of Boiler Pressure Part, Boiler 1 Hässelbyverket Stockholm Exergi

Panndagarna 2025

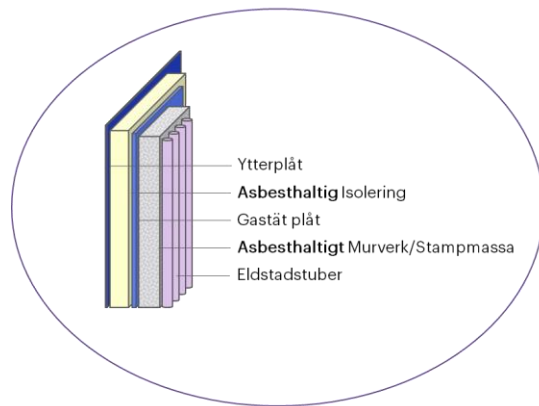
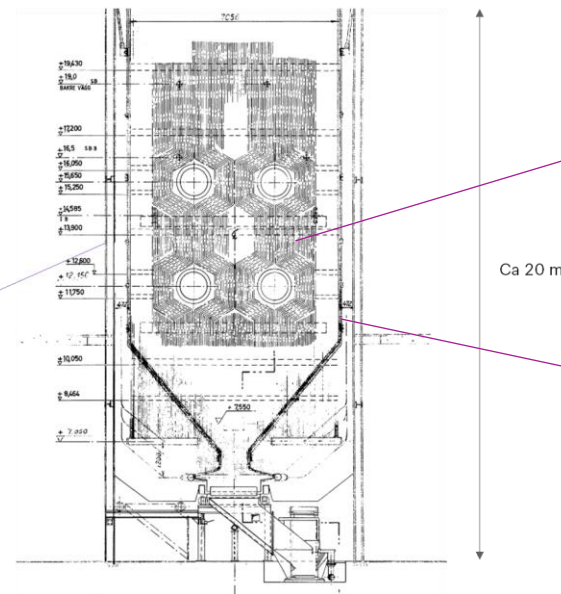
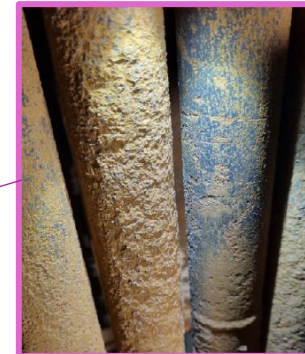
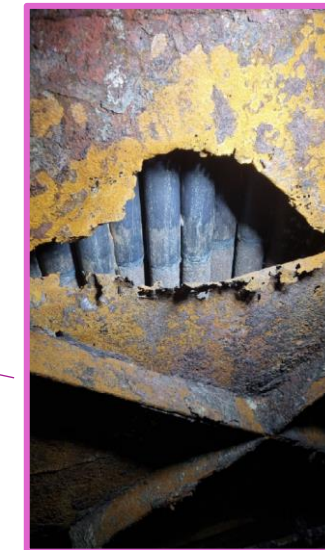
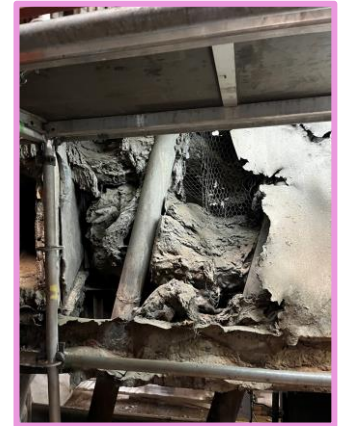
- Hässelbyverkets pannor P1, P2, P3 från 1959
- Tryckkärlens originalkonstruktion omfattar tätställda tuber med asbesthaltig murning/stampmassa
- Underhållsarbete P1 tryckkärl revision 2022 avbröts då sanerat område var asbestkontaminerat
- Projektet tillsattes december 2022

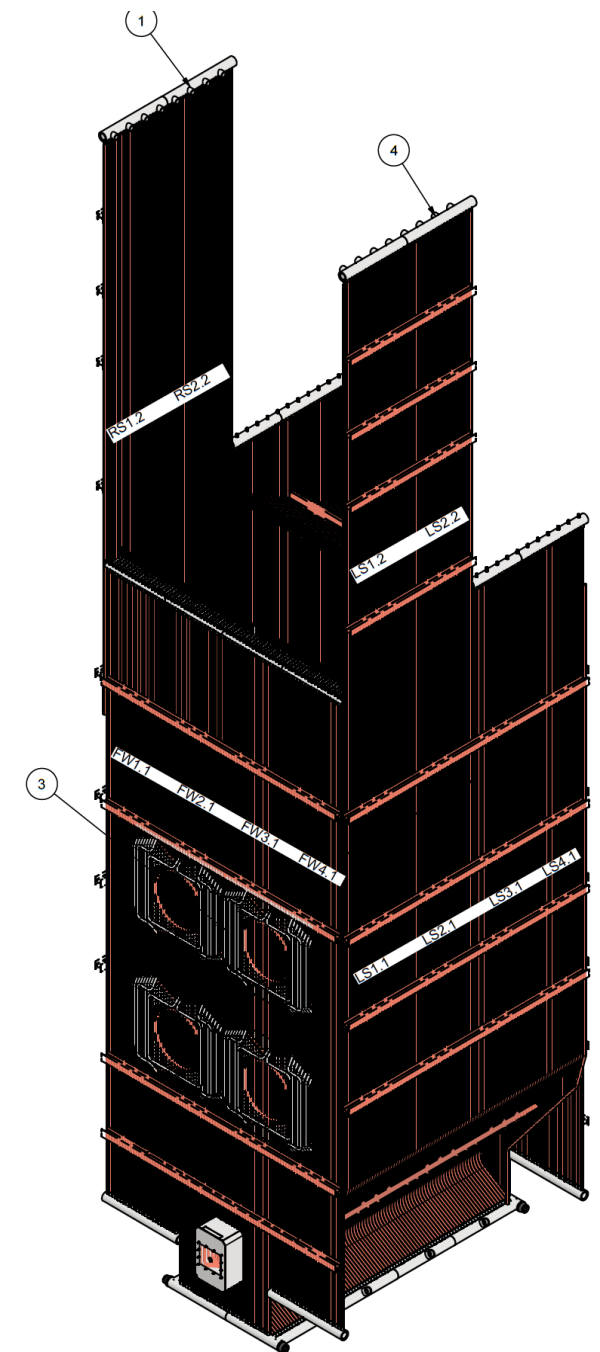
Byte av panntuber

- Nya panelväggar och samlingslådor
- Ny upphängning för brännare., brännarskåp hängs på panelväggar.
- Fler insprutningspunkter för SNCR
- Större manluckor
- Grundomfattning: ÖH tuber byts i alla de yttersta stråken
 - *utökad omfattning: Ett helt tubpaket i ÖH byts ut inkl. samlingslåda*
- Taktuber som demonteras under asbestsaneringen byts
- Stagbalkar på norra och södra vägg vid ÖH kommer att ersättas.

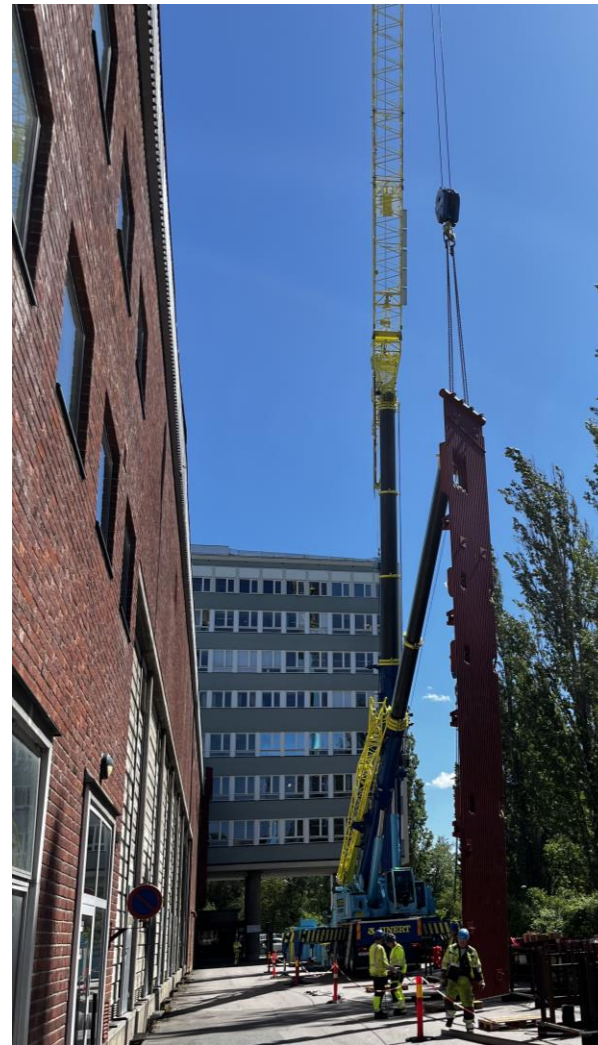
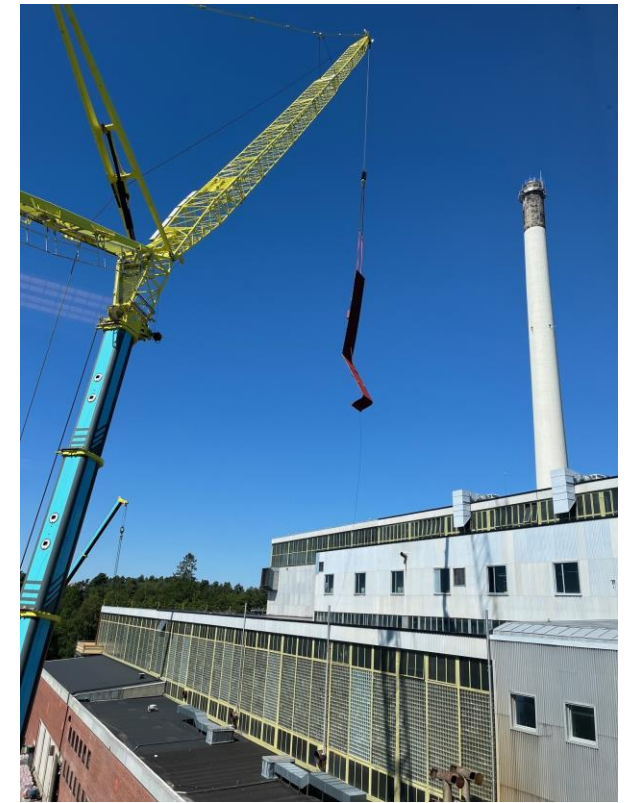
Installation panelväggar

- 16 bitar (18mx2m) lyfts in med kran
- Personalparkering avställd under 2-3 veckor
- Tillfälligt hål i pannhustak
- Kranuppställning på kommunens mark - tillstånd
- Vid varje lyft spärras delar av Hässelbyverket av
- Avväxling av väggar krävde speciallösning

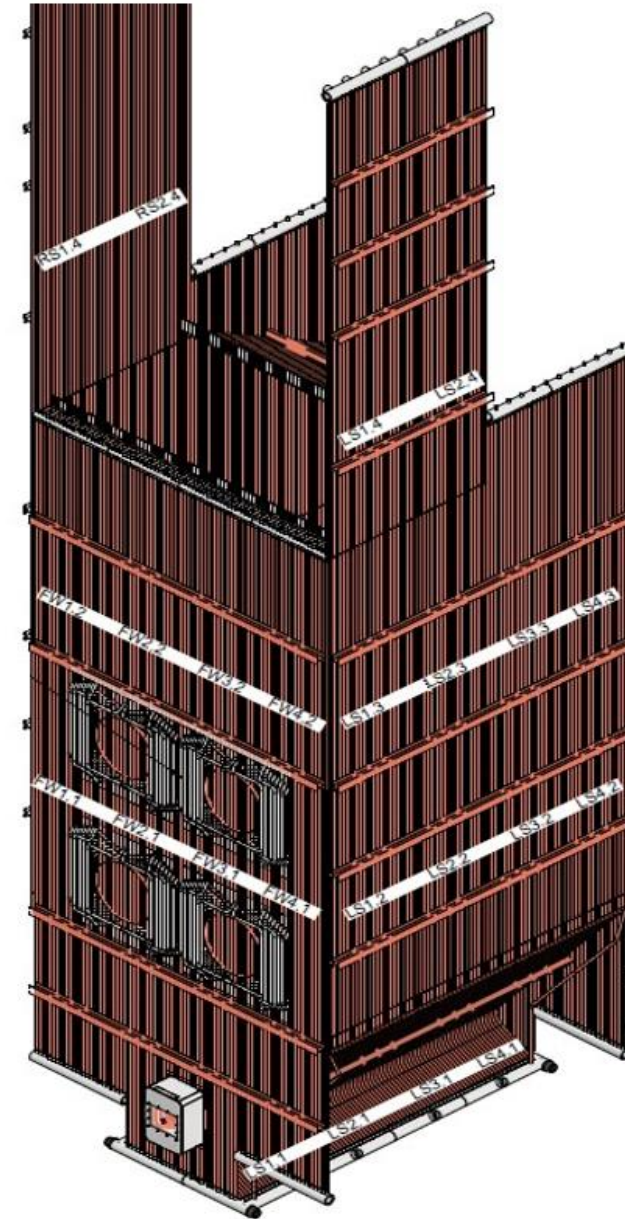
Conversion of boiler pressure parts with
“loose” tubes to boiler panel walls

In general, the new gas-tight membrane panel walls (tube size $\varnothing 60,3 \times 5,0$ mm and pitch 80 mm) was installed in 1st Pass. Panel walls were reinforced with beams HEB180. New panel walls was delivered with necessary openings for burners, sootblowers, SNCR and manddoors. Connection between the new panel walls with existing walls with lose tubes was done with conversion headers.

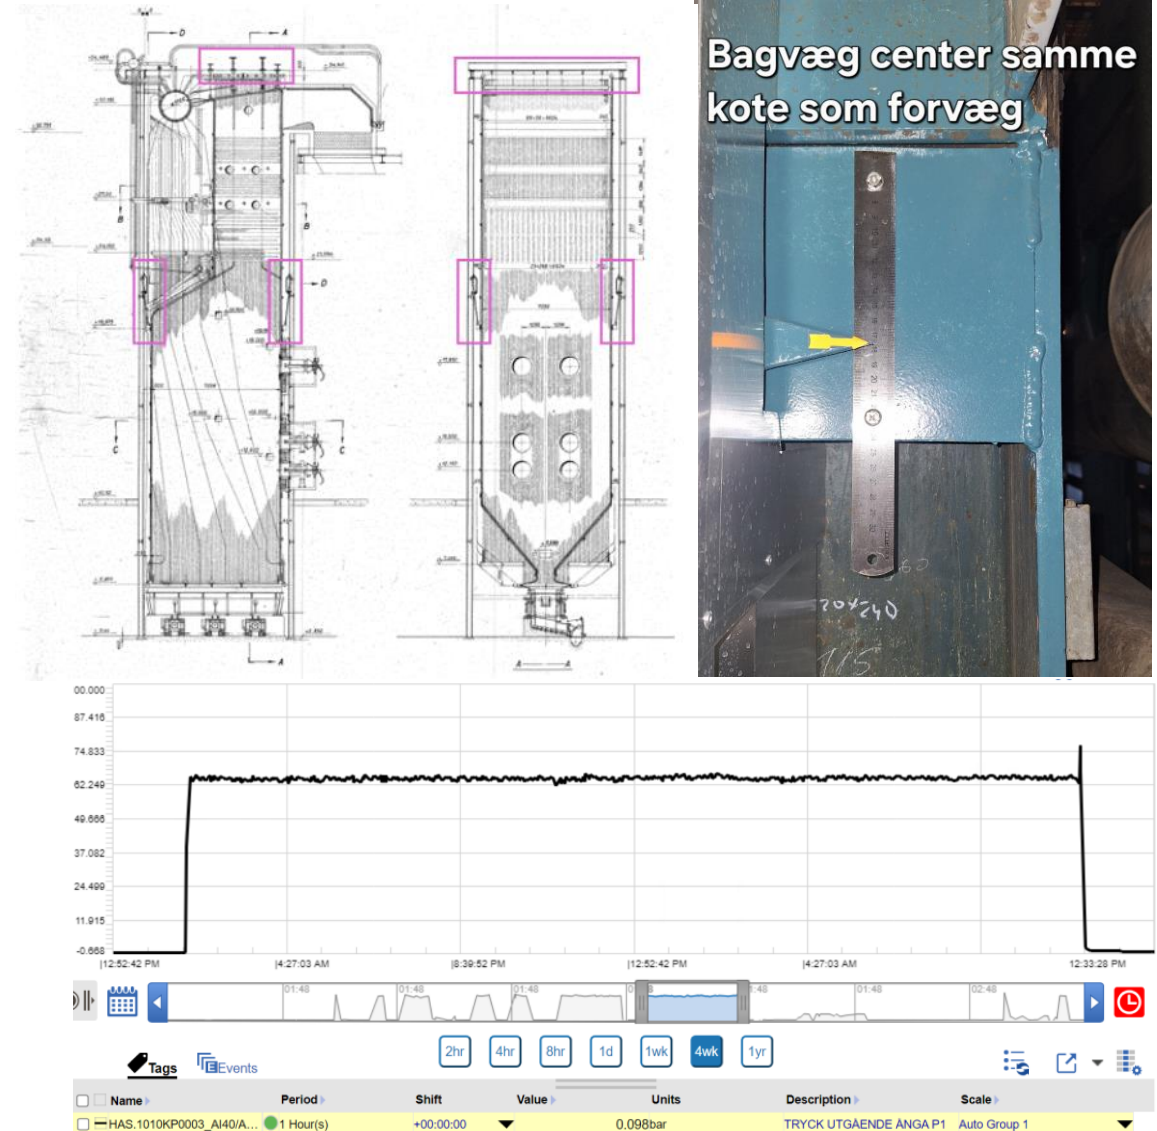
- The first pressure tests revealed 3 different leaks in the existing boiler tubes
- Measurement and adjustment of the boiler load in Cold and Hot conditions - It has been optimal to execute both cold and hot measurement and adjustment to secure a correct load on the supporting point and the external steel construction.
- The first tests are showing a better boiler performance than before.
- Test on Completion is done.
