Omfattande reparation Tryckkärl P1 Hässelbyverket

Anna Gabrielsson 2025-04-03

Extensive repair and upgrade of Boiler Pressure Part, Boiler 1 Hässelbyverket Stockholm Exergi

Panndagarna 2025

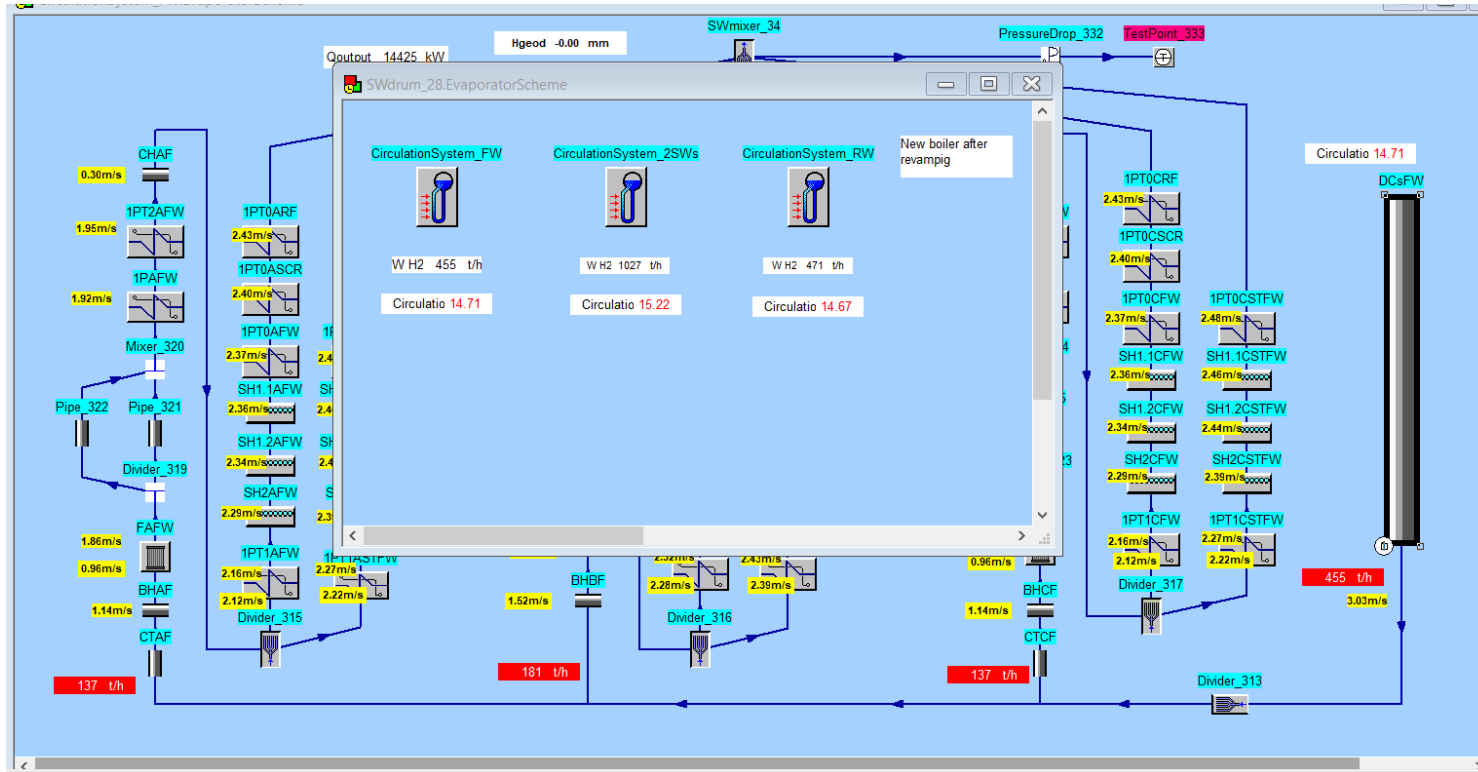
New boiler – circulation system for the entire boiler

Calculation results show little improvements of natural circulation ratios in all boiler walls for new boiler after revamping compared to existing (old) boiler.

For example, for Front Wall natural circulation number for new boiler after revamping is 14,71 compared to existing (old) boiler 14,17.
